Traction Sheave Maintenance

How to identify and prevent important issues with this critical elevator component

by John W. Koshak and Tim Ebeling

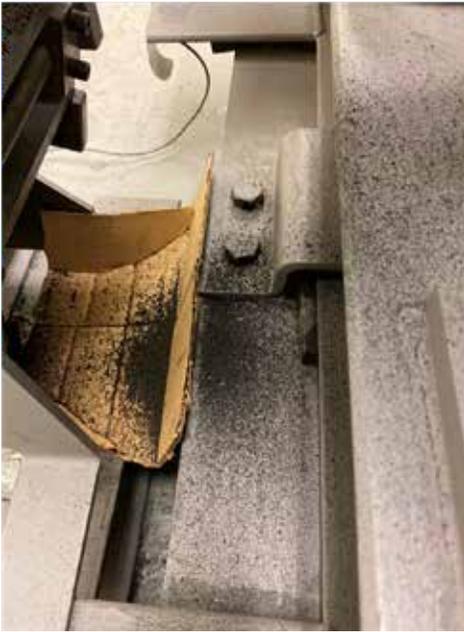
Figure 1 shows the accumulation of magnetic, steel particles under the counterweight-side pinch point of a geared traction driving machine. The elevator has a maximum speed of 1.75 m/s (350 ft/m), 11 stops, a front entrance only, runs an average of 1,700 times a day and is only seven years old. It is one of a triplex of units, yet the others (with same duty) do not show this loss of sheave material. What is the difference?

Figure 1: Example of metal particles under a pinch point

In Figure 1, this elevator's rope tension differences began a destructive course when the first material began grinding off the sheave groove due to unequally tensioned steel wire ropes. This was caused by maladjustment of the fastening, reduced rope diameter and reduced traction groove diameter. This loss of material then further prevents equalizing the rope tensions, further damaging the sheave groove. The initial culprit was unequal rope tensions from turnover, then never checking them again, then (even worse) seeing the ground particle material under the machine and still not correcting it. Proper maintenance should have been performed to verify 10% tension annually and adjust the rope tensions and measure the groove depths.

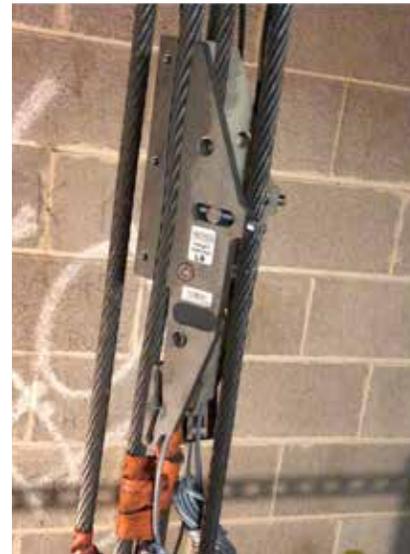
Figure 2: Henning LS1 rope gauge

WEARwatcher incorporates rope gauges on each rope that provide accuracy within 2.5%. This accuracy equals or surpasses mechanical systems. A previous article by one of your authors on alternative testing (“Safety and

WEARwatcher measures the dynamic rope tensions, which your authors considered the first place to look for the answer. Figure 2 shows the Henning LS-1 rope gauge when examination of the issue began.

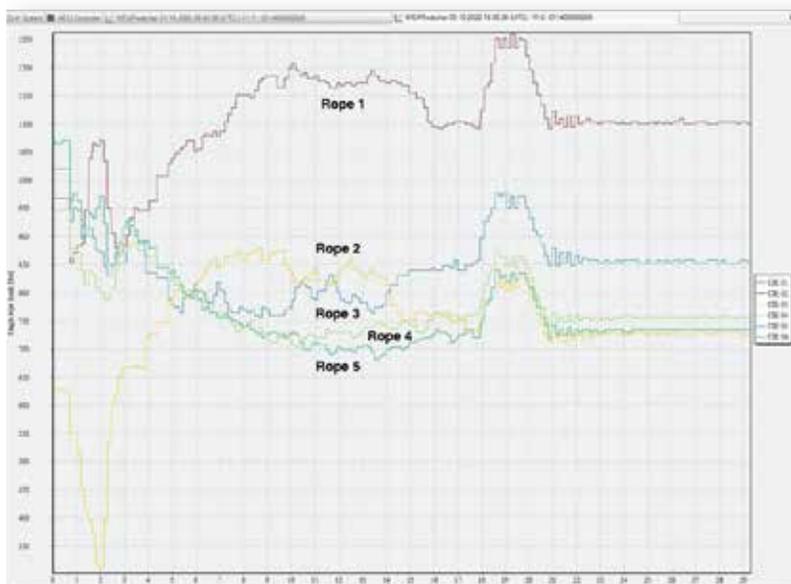
Figure 3: Rope tensions on October 9, 2020

From a stopped position, the highest tension is 1,070 lb (485 kg); 10% is 107 lb (49 kg). These ropes were out of tension by 333 lb (151 kg), approximately 31%. But, during the run, at time “13.5,” rope 1 measured 1,200 lb (545 kg), and rope 5 measured 680 lb (309 kg). So, the tension differences grew larger, a difference of 520 lb, or 43%. Therefore, WEARwatcher was sending constant error messages to equalize the ropes.

During the run, the tension differences changed: ropes 1 and 2 increased tension, while ropes 3, 4 and 5 decreased tension (Figure 3). Two things to note: measurement of the rope tensions while the elevator is stopped in the hoistway cannot determine dynamic changes, providing probably the single clearest explanation of why it is sometimes impossible to equalize rope tensions on some jobs. Seeing the changing rope tensions is a breakthrough in elevator maintenance; this is something we were unable to see before.

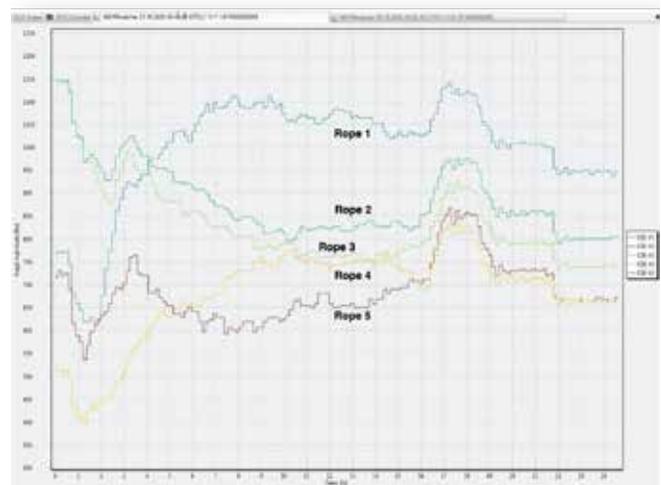
The accuracy of the gauges was called into question because the values were changing so much. To verify that the LS rope gauges were not sending out anomalous information, the maintenance contractor moved all the LS gauges to different ropes and attempted equalizing them. After this was done with the elevator at the first floor and then the car was run, there were similar unequal rope tensions again (Figure 4). The LS rope gauges were verified; they moved to ropes of different tensions as shown by the color changes in the graphs. The gauge was assigned a color, and moving it to another rope changed the rope color. In Figure 3, “brown” was on rope 1, then moved to rope 5 in Figure 4. After proving the LS rope gauges were not the problem, the next step was to concentrate efforts on equalizing the ropes. This was attempted, as shown in Figure 5.

Figure 4: Chart of rope tensions on October 11, 2020

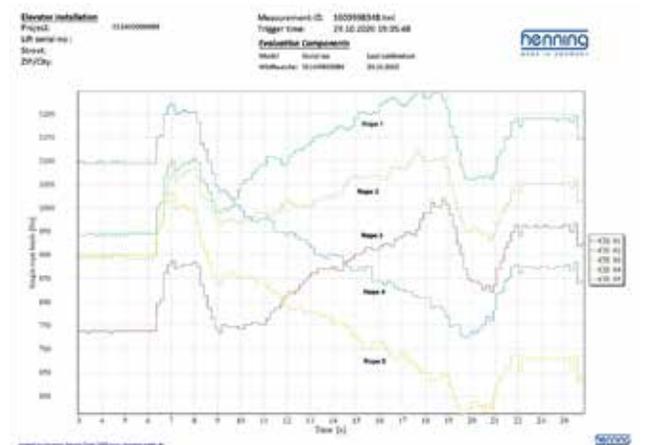
Figure 5: Chart of rope tensions on October 29, 2020

and down several times. Measuring the tensions, adjusting the shackles, then running the car put the ropes out of balance every time. Looking closer at the Figure 5, during this run, ropes 1, 2 and 3 show increasing tension, while ropes 4 and 5 showed decreasing tension. Looking back at Figures 3 and 4, this also documents rope tensions that increased and decreased during travel.

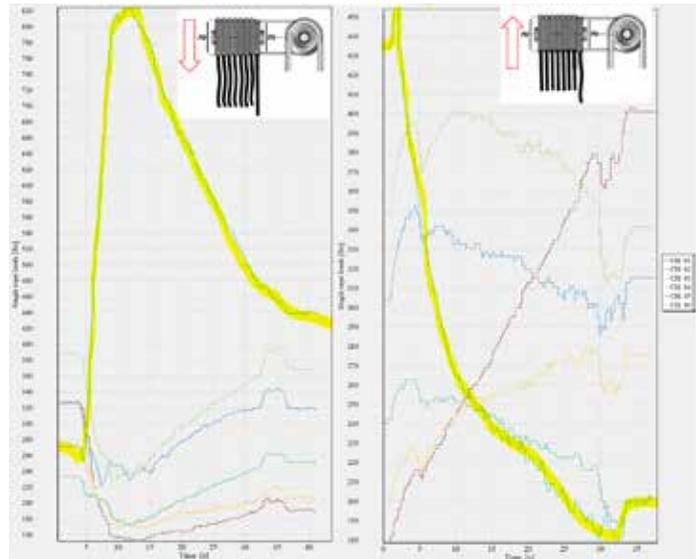
Figure 6 shows this behavior in an extreme example. The highlighted rope is from two recordings of different elevators. The increasing tension in the down run is highlighted on the left, and the decreasing tension in the up run is highlighted on the right. That variant tension causes rope slip and the much harder steel wire rope to grind sheave material as seen in Figure 1.

Figure 6: Illustration of tension changes with diameter differences; courtesy of Henning

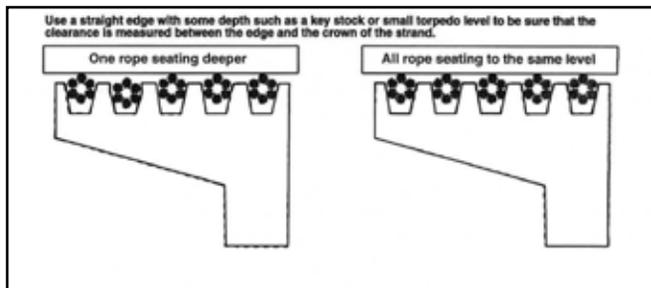
Determining the condition of the relative sheave groove depth/rope diameter is done by placing a straightedge across all the ropes at the top of the sheave (overhead driving machine) or at any point where all the ropes are fully in the grooves (Figure 7). Careful measurement for any variance in the rope crown heights will show either a rope or groove diameter difference. Where the traction sheave has grooves deeper than the outer edge of the sheave, place the straightedge, and use feeler gauges to measure if the gaps over the crown are equivalent.

Figure 7: Illustration determining groove depths; from *Elevator Maintenance Manual* by Zack McCain
